TPI, Inc.

EPA Notification of Preliminary Findings

RCRA 560247

TPI, Inc. Response to EPA Notice of Preliminary Findings

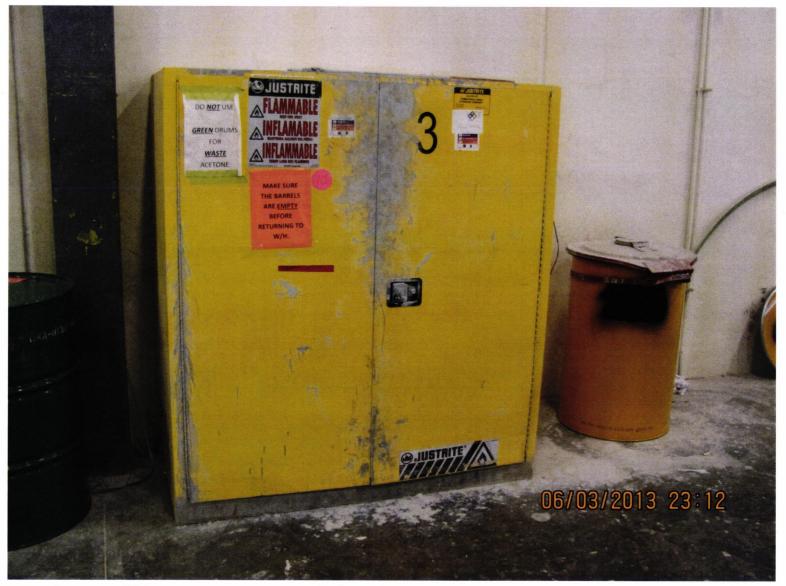
Satellite Accumulation Area in Question

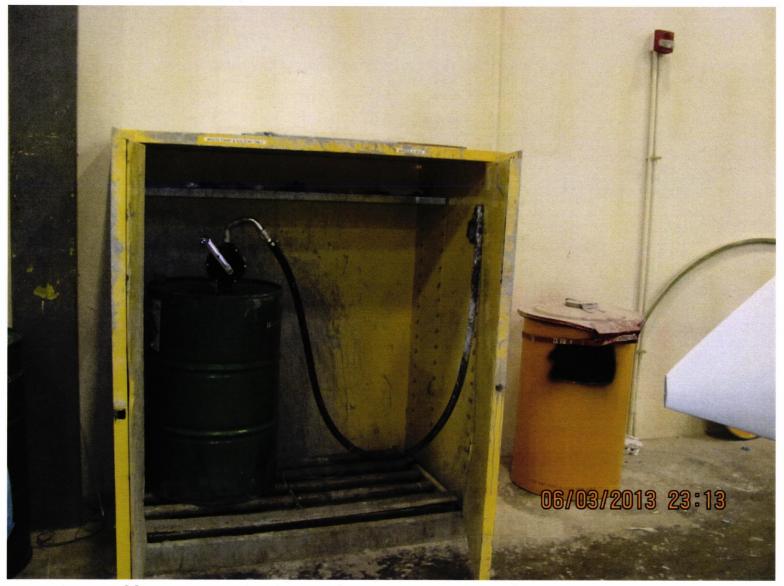
Satellite Accumulation Area in Question

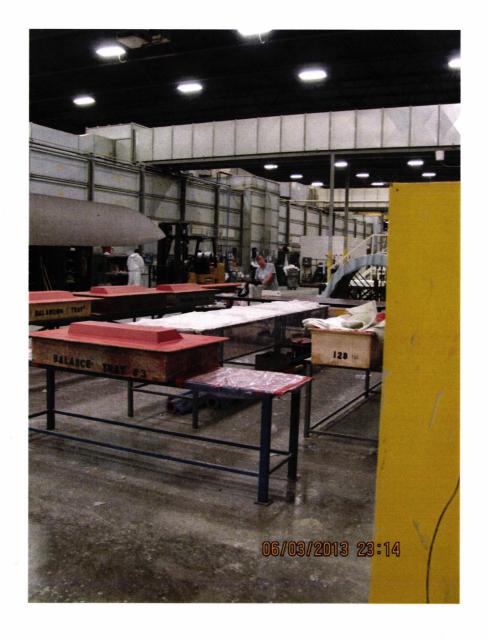
View from SAA to work area where waste is generated

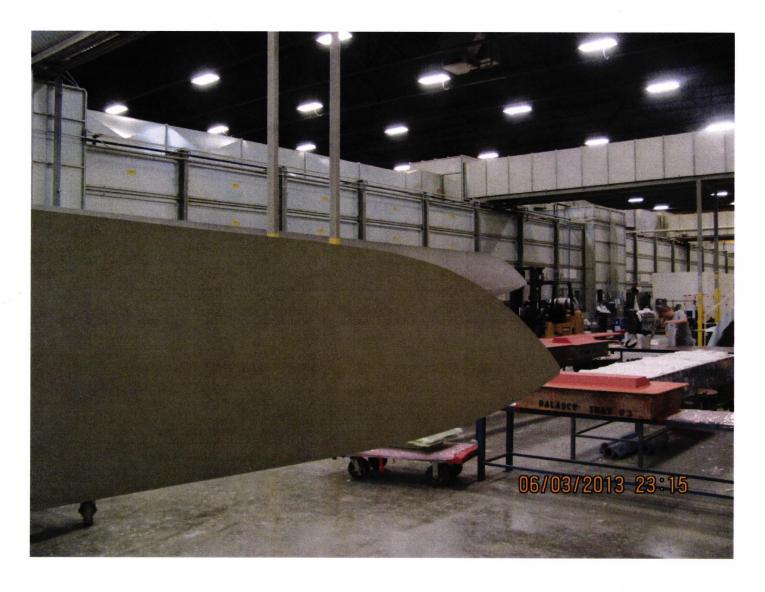
View from SAA to work area where waste is generated
